Manhole Inspection Summary

Manhole # S37U1_020MH

Insp Date: **6/2/09 1:14 PM**

Location Address: **S Hanover St**

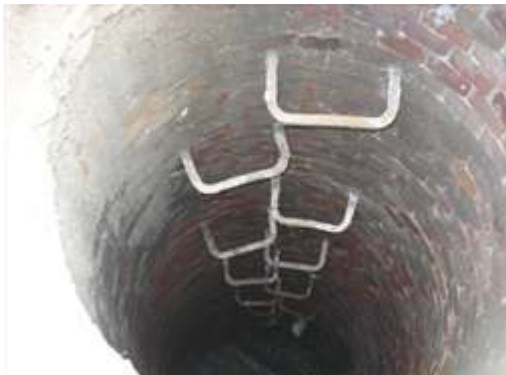
Steps Count: **13** Missing: **0** ☐ Corroded

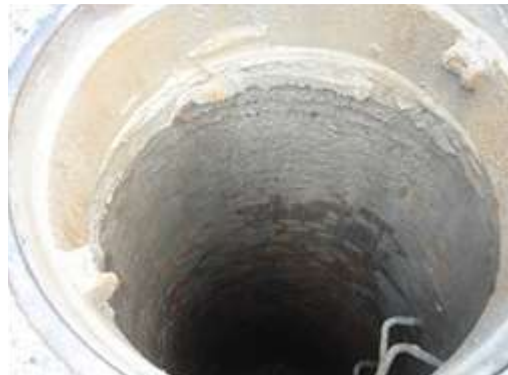
Defect 1

Frame Offset: **2** (in.) Condition: ☒ Sound ☐ Cracked ☐ Leaks

Frame Offset

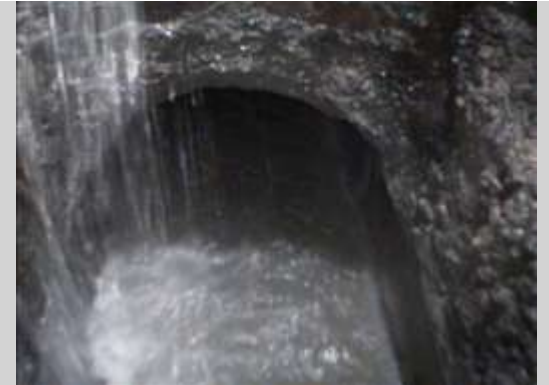
12 O'Clock Outflow

24 in. Circular Gravity Sewer
Pipe Out @ 12 O'Clock

Pipe Height: **24** (in.) Rod and Bar (Angled)
Pipe Material: **Concrete** ☐ Pipe Lined
Invert Depth: **21.66** (ft.) Flow Characteristics: **Turbulent**
Deposits: ☒ None ☐ Mud ☐ Sludge ☐ Debris ☐ Grease
Silt Depth: (in.) Deposits Extent:
Infiltration: **None** Pipe Seal Cond: **Sound**

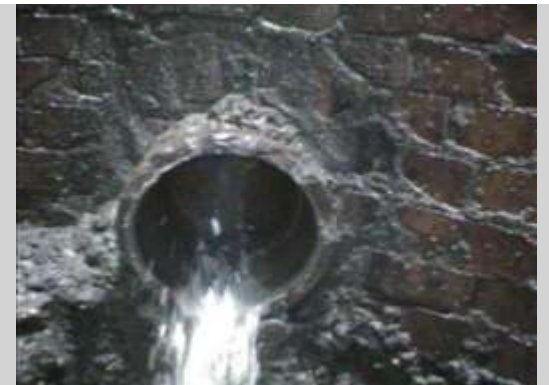
5 O'Clock Inflow

8 in. Circular Gravity Sewer
Pipe In @ 5 O'Clock

Pipe Height: **8.4** (in.) Rod and Bar (Angled)
Pipe Material: **Clay** ☐ Pipe Lined
Invert Depth: **12.08** (ft.) Flow Characteristics: **Fast**
Deposits: ☒ None ☐ Mud ☐ Sludge ☐ Debris ☐ Grease
Silt Depth: (in.) Deposits Extent:
Infiltration: **None** Pipe Seal Cond: **Sound**

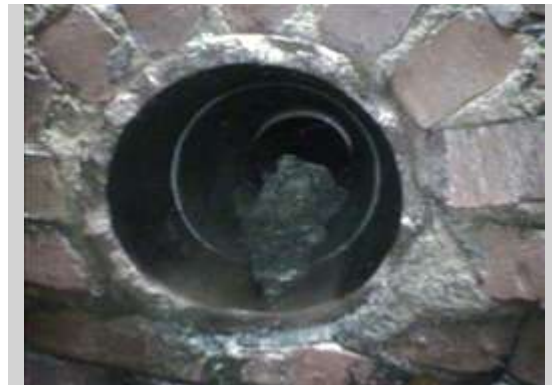
Drop In @ 5 O'Clock

Drop: **Inside** Rod and Bar
Angled: **Yes** Reading: **18.42** (ft.)
Inv Depth: **19.42** (ft.)
Drop Condition: **Open**

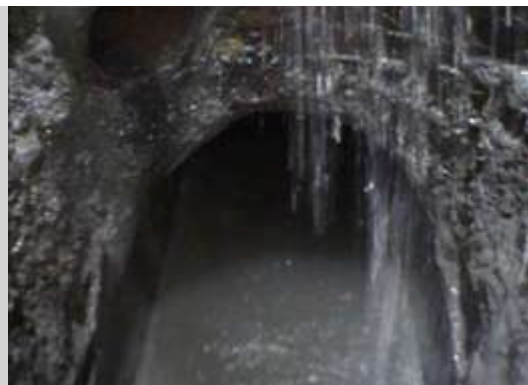
6 O'Clock Inflow

24 in. Circular Gravity Sewer
Pipe In @ 6 O'Clock

Pipe Height: **26.4** (in.) Rod and Bar (Angled)

Pipe Material: **Clay** ☐ Pipe Lined

Invert Depth: **21.94** (ft.) Flow Characteristics: **Turbulent**

Infiltration: **None** Pipe Seal Cond: **Sound**
